City of Kodiak
Kodiak Historical Society

RUSSIAN-AMERICAN COMPANY MAGAZIN
KODIAK, ALASKA
Historic Structure Report

MARCH 22, 2022

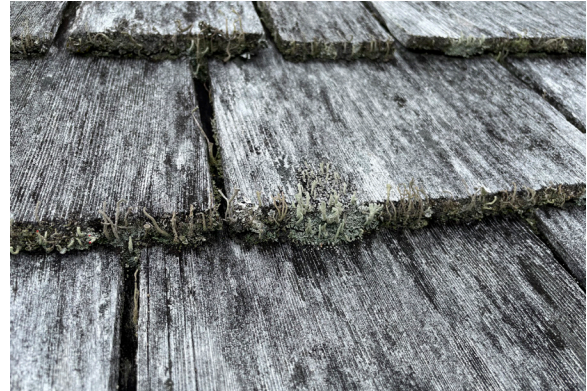
Figure 1-141. Significant bio-growth at cedar shingles. (KAC, 08/24/2021)

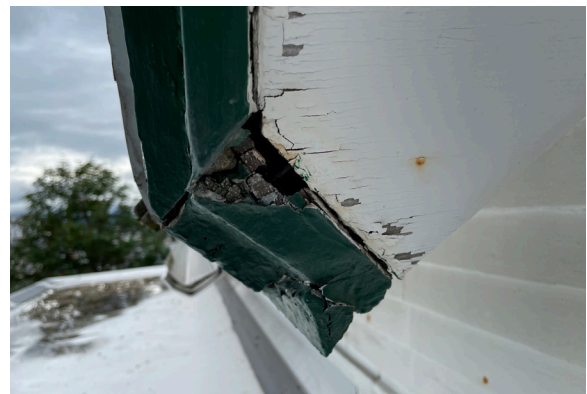
Wood trim and fascia elements are in fair to poor condition. Where exposed, ends of wood trim are rotted. Paint is mostly intact. Although nail-heads are concealed with paint,

Figure 1-142. Deterioration at the end of wood fascia and trim. (KAC, 08/24/2021)

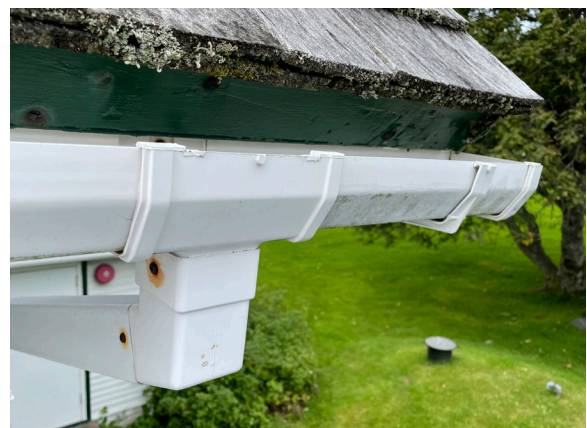
Figure 1-143. Shingles overhang the undersized gutters. (KAC, 08/24/2021)

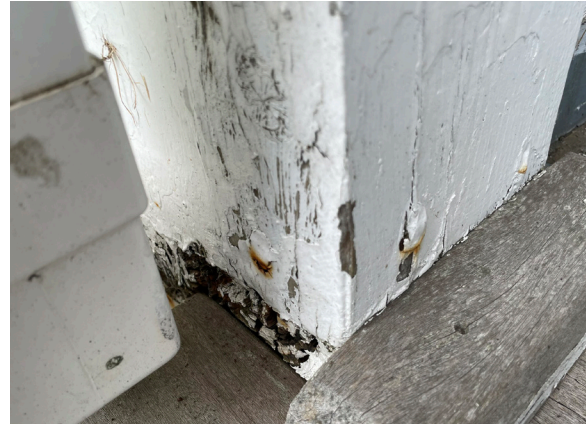
Figure 1-150. Deteriorated column base. (KAC, 08/24/2021)

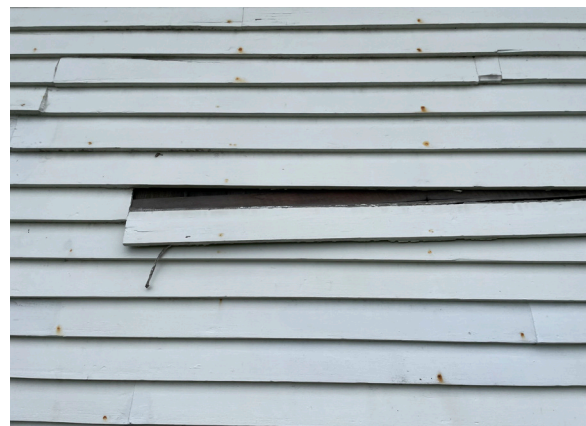
Figure 1-157. Loose siding board on the north facade. (KAC, 08/24/2021)

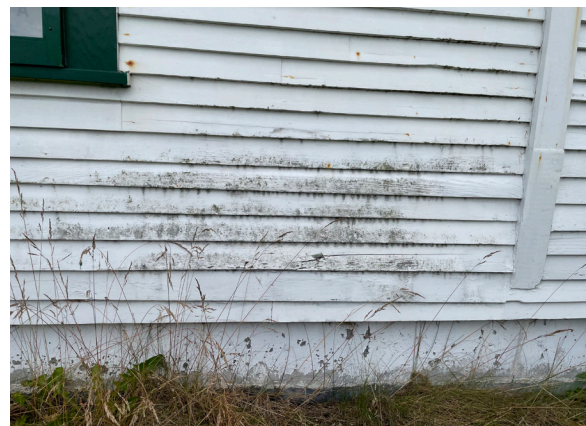
Figure 1-158. Deteriorated siding on the north facade, below the missing downspout. (KAC, 08/24/2021)

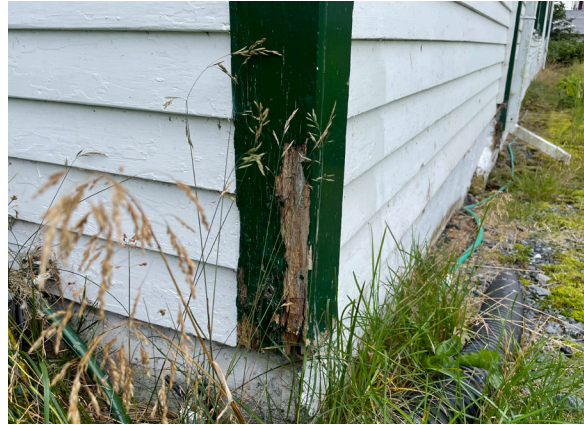
Figure 1-159. Deteriorated edge trim at northeast corner of the building. (KAC, 08/24/2021)

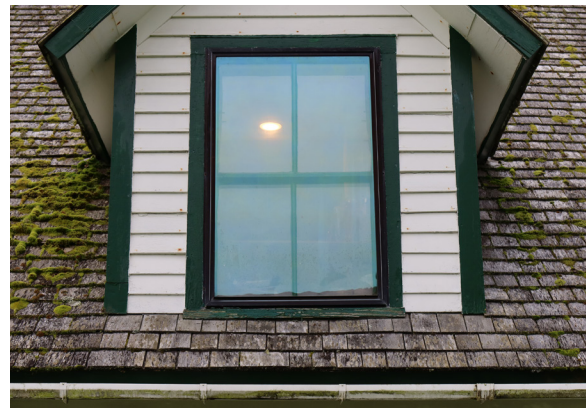
The sill at Window 30 is significantly deteriorated and in poor condition. Casing

Figure 1-163. Deteriorated sill at Window 30, Type C. (EAV, 08/24/2021)

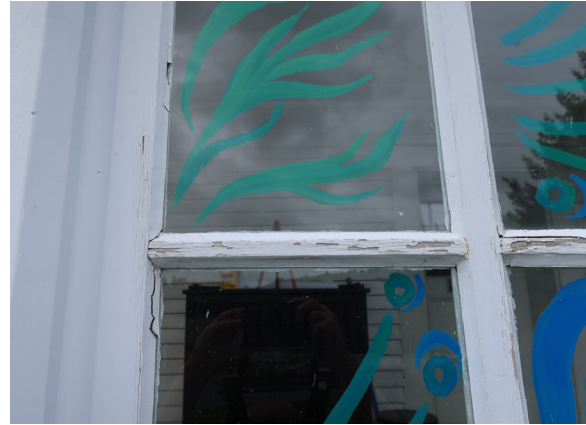
Figure 1-192. Missing paint and cracked glazing putty at Window 09. (EAV, 08/24/2021)

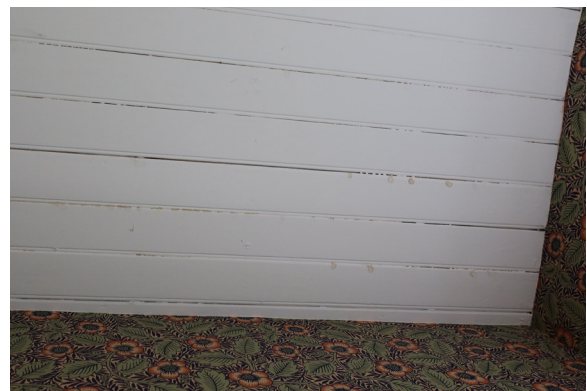
Figure 1-287. Water staining at alcove ceiling in Museum I 102. (EAV, 08/24/2021)

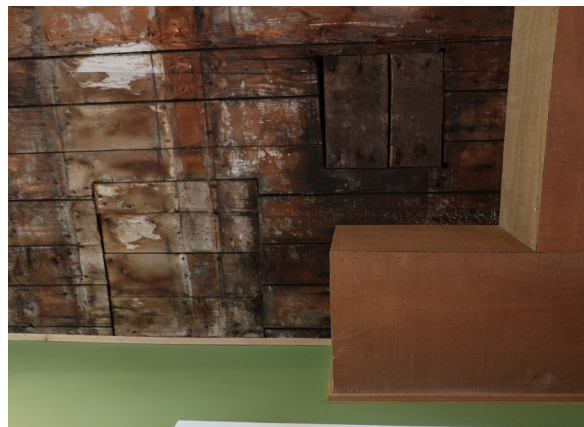
Figure 1-290. Patched and stained ceiling boards in Museum II 104. (EAV, 08/24/2021)

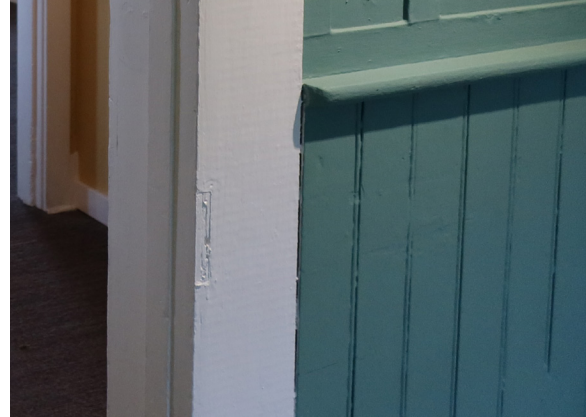
Figure 1-293. Scratched finishes with thickly applied paint in Kitchen 108. (EAV, 08/24/2021)

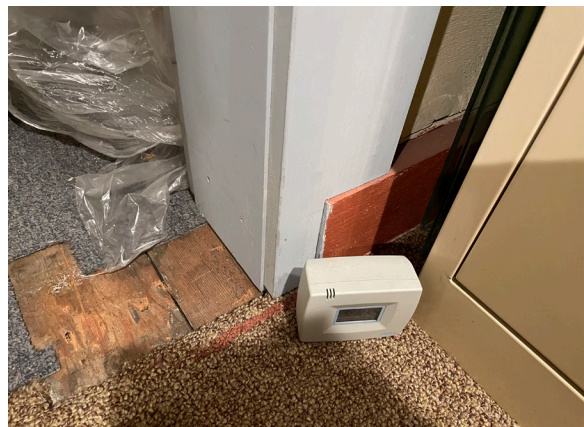
Figure 1-305. Missing carpet reveals wood floor boards at CO 201A. (KAC, 08/24/2021)

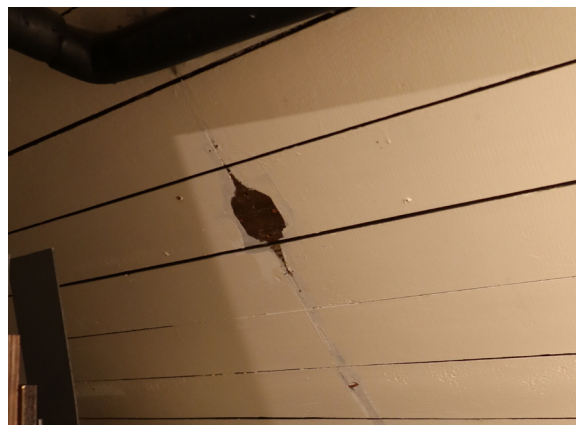
Figure 1-329. Missing paint from previous attachments in Eunice 201A. (EAV, 08/24/2021)

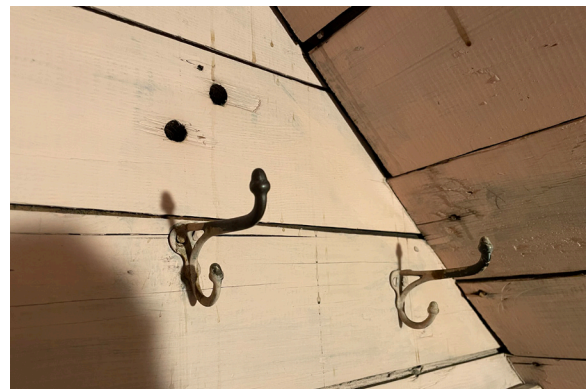
Figure 1-332. Scratched paint and holes from previous attachments in Storage 205A. (EAV, 08/24/2021)

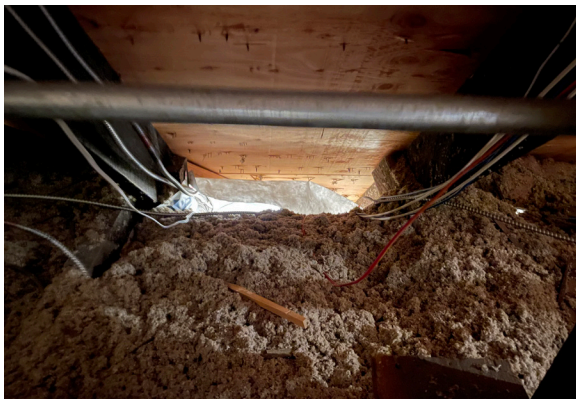
Figure 1-340. Loose insulation at perimeter of Attic I 300. Light is visible from Storage 205B below. (EAV, 08/24/2021)

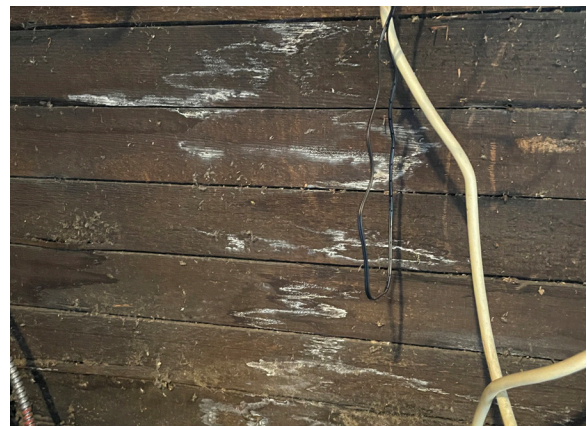
Figure 1-343. Smoke stain and efflorescence on exposed sheathing at the east wall of Attic I 300. (EAV, 08/24/2021)

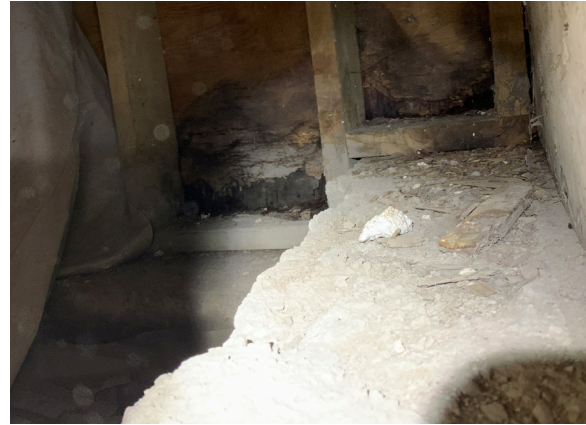
Figure 1-346. Interior face of the north wood stud foundation wall of the Alcove. Note the water staining and deterioration at the base of the wall (CBB, 08/25/2021)

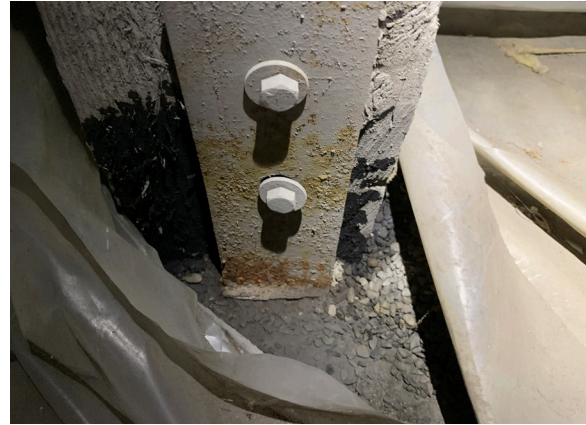
Figure 1-348. Deteriorating and disintegrating concrete at the interior isolated concrete footings (CBB, 08/25/2021)

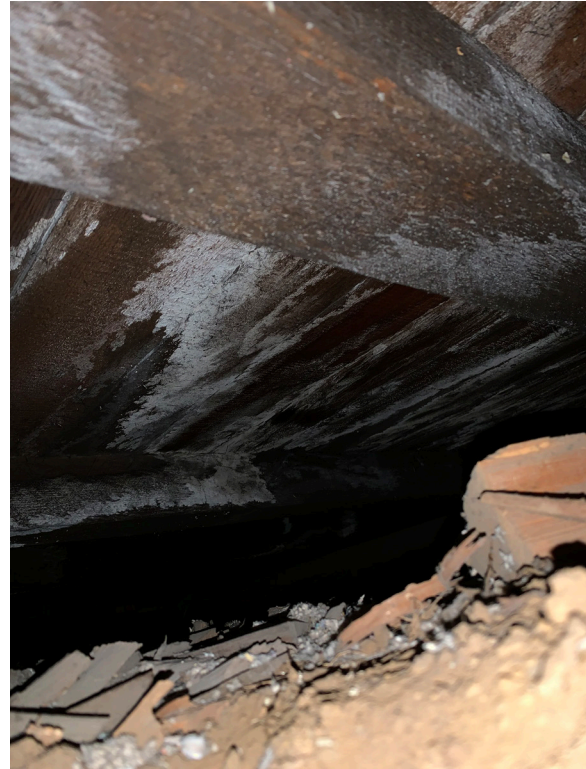
Figure 1-353. Second floor framing cavity of the Magazin on the east half of the structure. Note the 4x4 joists at the top of the cavity and the mold or water staining visible on the wood members (CBB, 08/25/2021)

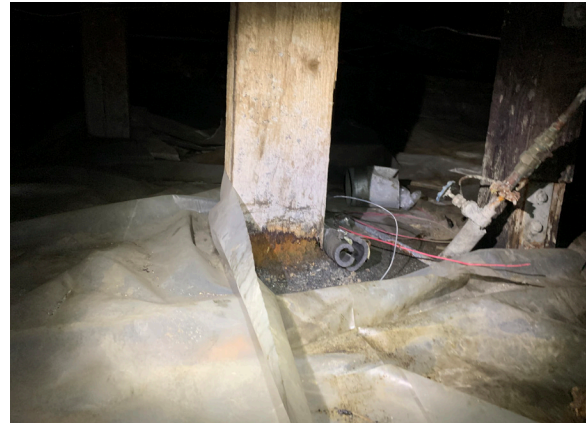
Figure 1-355. Deteriorating base of a post supporting the first floor of the Magazin (CBB, 08/25/2021)

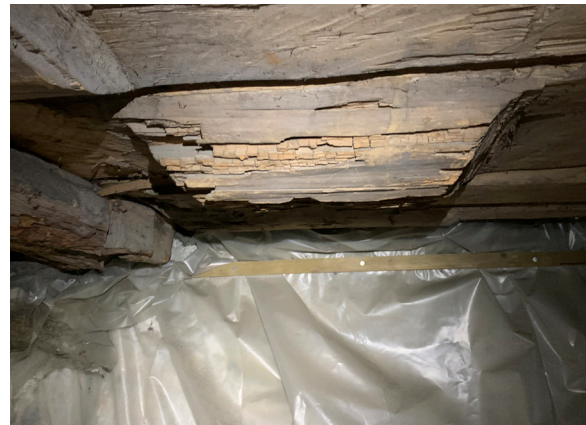
Figure 1-356. Deterioration visible on a first floor deck board (CBB, 08/25/2021)

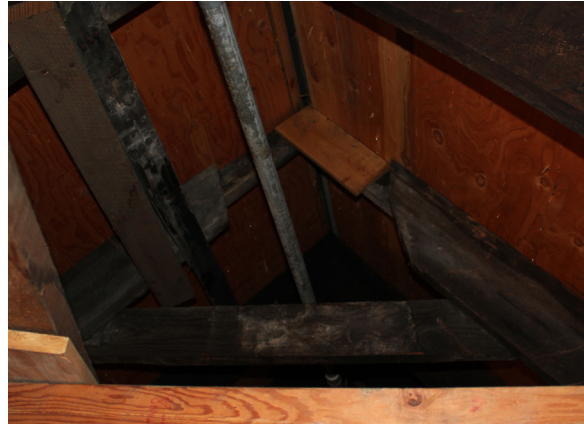
Figure 1-367. In one location, the rafters have been cutback from the peak of the roof and sistered (CBB, 08/26/2021)

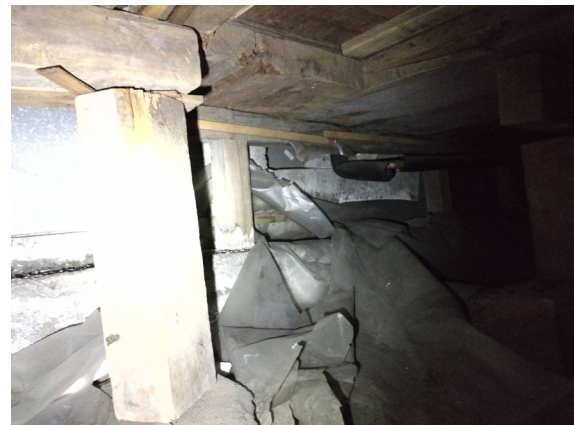
Figure 1-387. Damaged Cast-Iron Waste Pipe (JSW 8/24/2021)
