City of Kodiak
Kodiak Historical Society

RUSSIAN-AMERICAN COMPANY MAGAZIN
KODIAK, ALASKA
Historic Structure Report

MARCH 22, 2022

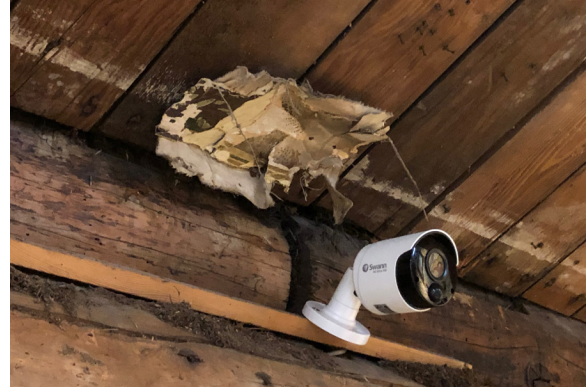
The ceiling in this room consists of unpainted wood boards, and there are remnants of wallpaper or canvas cladding in places (Figure 1-61). The ceiling boards are original or from an early period of the building's evolution.

Figure 1-61. Remnants of wallpaper at ceiling. (BM, 08/24/2021)

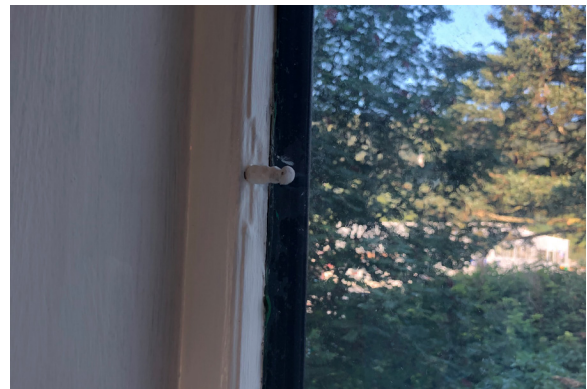
Figure 1-63. Windows are painted shut. (BM, 08/24/2021)

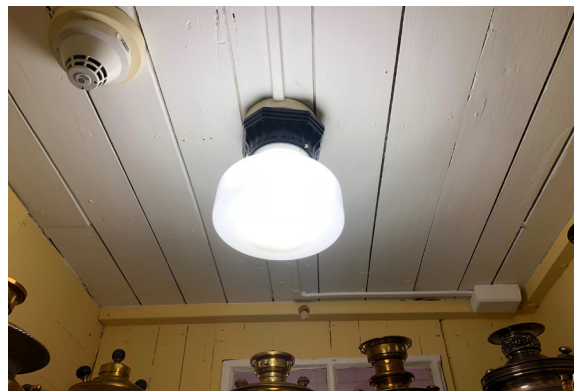
A wood door leads to the pantry. The door frame is wood and painted white. The Pantry walls and ceiling consist of vertical wood boards similar to those found at the Entry Hall and Stair. The Pantry has wood shelving that wraps around the south, east and west walls (Figure 1-77 and Figure 1-78).

Figure 1-78. Ceiling of Pantry 106. (BM, 08/24/2021)

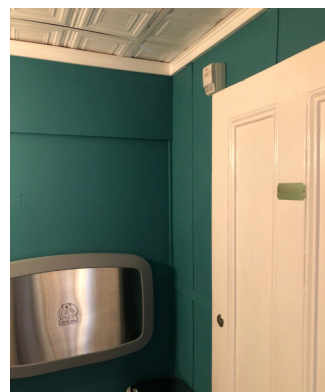
The Restroom (107) has a wood panel door. The door frame is wood and painted white (Figure 1-79). The Restroom walls are finished in gypsum wallboard, similar to the Entry Hall and the adjacent Hall. The ceiling in this space consists of a system of modern, dropped, decorative, pressed tin panels similar to other portions of the east side of the first floor of the Magazin (Figure 1-79). The configuration of this room and the fixtures present in this room date to after the Erskine era as the bathroom during the Erskine era was located where Museum III (111) is now.

Figure 1-79. Southeast corner and modern ceiling in Restroom 107. (BM, 08/24/2021)

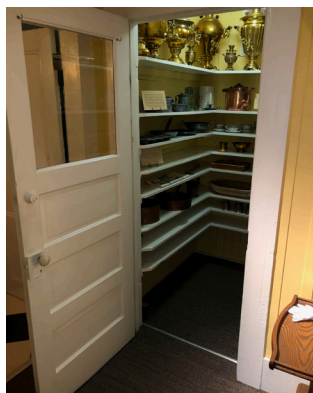
Figure 1-77. Facing south into Pantry 106. (BM, 08/24/2021)

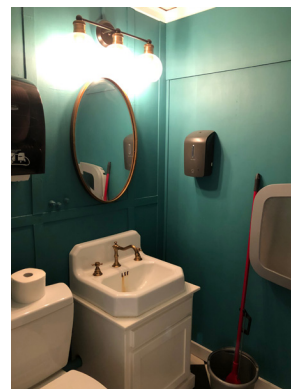
Figure 1-80. Facing northeast in Restroom 107. (BM, 08/24/2021)

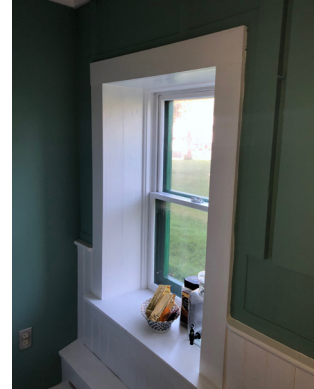
This is a new room at the northeast corner of the kitchen, enclosed in 2019. The east and north walls are covered in gypsum wallboard above a vertical wood wainscot. The ceiling in this space consists of a system of modern, dropped, decorative, pressed tin panels similar to other portions of the east side of the first floor of the Magazin (Figure 1-83). The north wall has two original window openings with deep sills and wood trim painted white (Figure 1-84).

Figure 1-84. Window at north wall of Staff Kitchen 109. (BM, 08/24/2021)

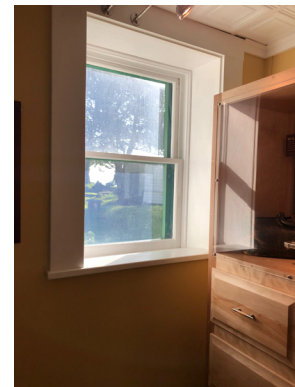
This small space is accessed from a cased opening along the south wall of the Kitchen (Figure 1-85). The room has a mix of gypsum wallboard and modern gypsum board, for its wall surface. The ceiling in this space consists of a system of modern, dropped, decorative, pressed tin panels similar to other portions of the east side of the first floor of the Magazin. The header and sill of the window on the east wall is located higher than other windows throughout this section of the building. This window may have changed when this room was used as a restroom, perhaps as early as the first part of the twentieth century (Figure 1-86).

Figure 1-86. Window 25. (BM, 08/24/2021)

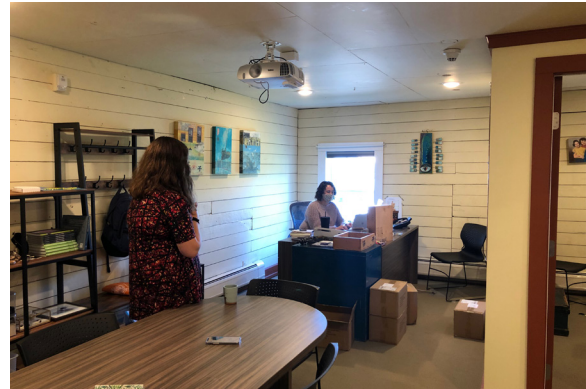
Room 206 is separated from Room 205 by a dividing wall that terminates mid room and does not have a door. At the far southwest corner there is a double-hung, six-over-six, wood window with wide wood trim. The wall finish in this space generally consists of the five-inch-wide, horizontal, tongue-and-groove, wood boards that are found in other second floor rooms; however, there has been some intermittent patching of differing widths. These likely relate to various repairs, wiring or plumbing changes over the years (Figure 1-113).

Figure 1-113. Facing southwest in Office II 206. (BM, 08/24/2021)

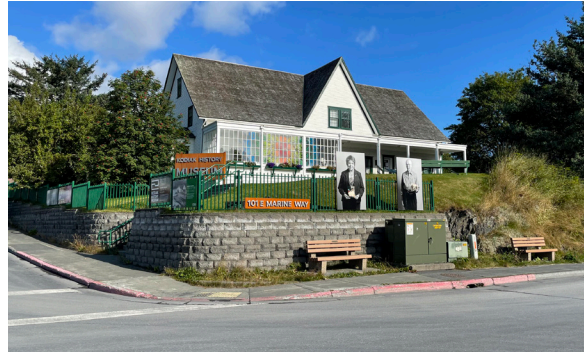
The site is generally in good condition. Concrete walks, steps, and walls are in good condition. Gravel walks and parking vary in condition and require repair. Much of the site drains to the foundation of the building. Repair is needed to establish positive

Figure 1-128. Concrete block retaining walls rise along Center Street and East Marine Way (Anderson Hallas, 2021).

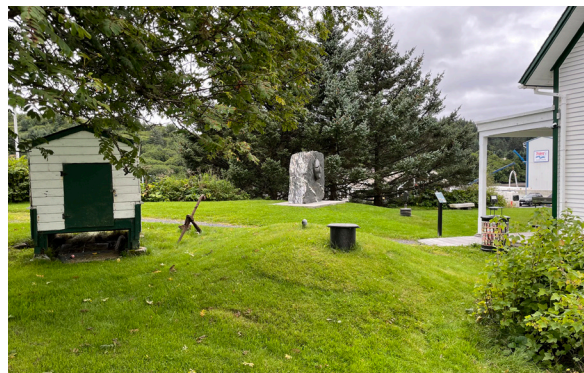
Figure 1-129. A mound to the east of the building marks the location of a buried fuel tank (Anderson Hallas, 2021).

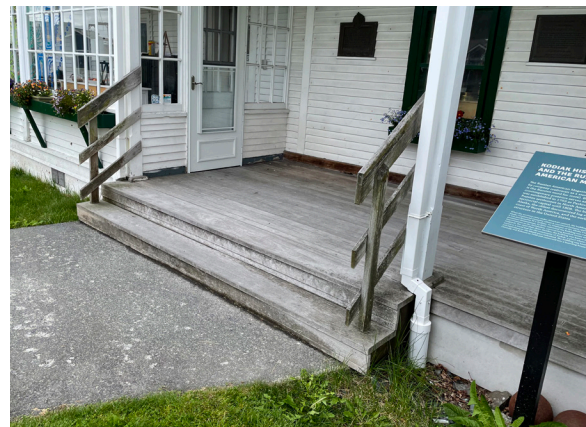
Figure 1-149. Step leading to the porch. (KAC, 08/24/2021)

Some bio-growth was observed along south and east decking boards, where they are most exposed to weathering. The bottom riser of the step is dark with water damage and bio-growth where it meets the ground.

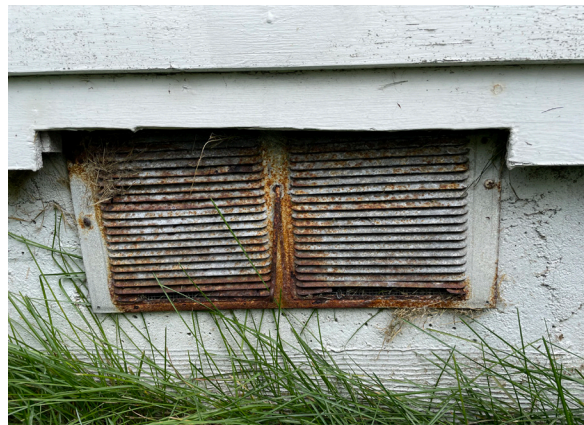
Below the wood siding, the concrete foundation, painted white, is visible at the base of the exterior walls. Metal vents with fixed louvers are intended to provide ventilation to the crawlspace through the foundation. These are painted white on the exterior and covered with sheet metal on the interior, blocking the flow of air through the vent. Along the north facade, the wood siding is notched to accommodate the vents. The vents are not historic elements.

Figure 1-160. Foundation vent and notched siding at the north facade. (KAC, 08/24/2021)

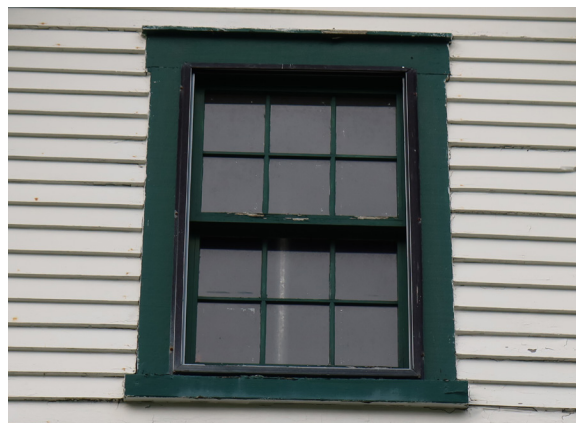
Figure 1-189. Window 34, Type D. (EAV, 08/24/2021)

This Type D window has an incompatible aluminum storm frame that is missing glazing and so does not protect the window.

Windows are overall in fair condition. All glazing is intact, with the exception of the storm at Window 34.

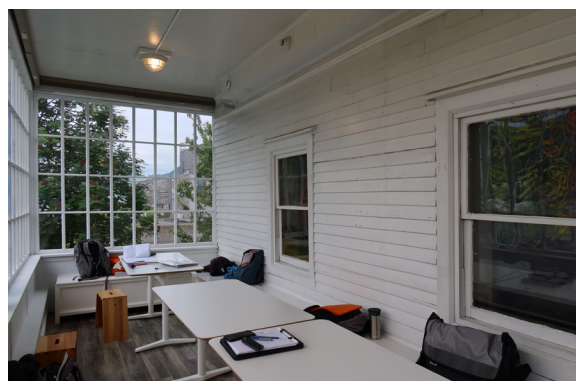
Figure 1-191. Built-in bench in front of Windows 05 and 06. (EAV, 08/24/2021)

in front of Windows 05 and 06 such that a person sitting down may lean back against the single-pane untempered glass of the bottom sash. This is a concern both for the safety of building occupants and for the condition of the windows.

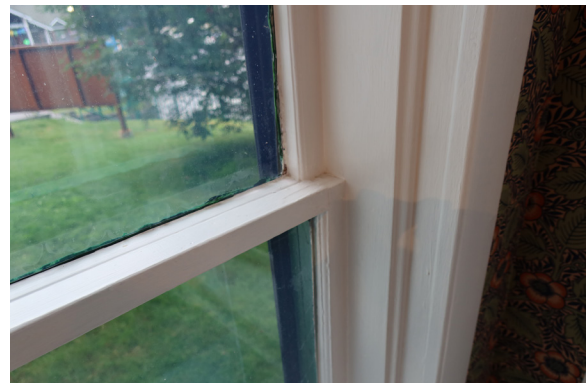
Figure 1-193. Window 15, interior. Note visible paint on glazing and sashes painted shut. (EAV, 08/24/2021)

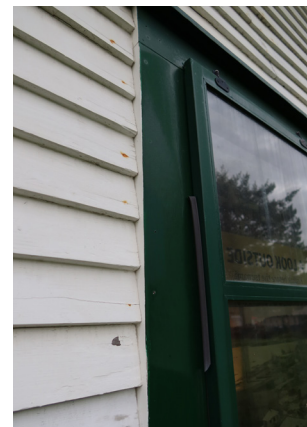
Good to fair condition. The rubberized sealant strip between the storm and sash is loose and hanging down. Without a strong seal between storm and sash, water infiltration and damage will occur.

Figure 1-194. Loose sealant strip at storm of Window 22. (EAV, 08/24/2021)

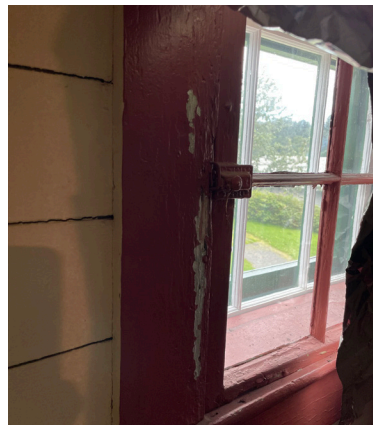
Figure 1-195. Window 31, interior. (KAC, 08/24/2021)

Good to fair condition. This window is covered on the interior by a sheet of tin foil loosely affixed with scotch tape. Access to this window on the interior is limited by collections storage. Operation could not be tested. Paint on the interior is thickly applied and cracked. There is also paint on the glazing.

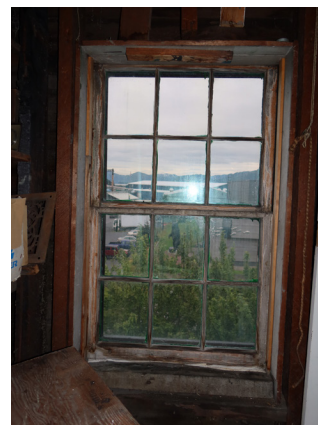
Figure 1-196. Window 33, interior. (EAV, 08/24/2021)

Fair to poor condition. Glazing is intact. Glazing putty and paint are not cleanly applied and are visible from the interior. Wood elements are not painted on the interior. Water staining was observed on both sash and the interior sill. A paper towel has been stuffed between the bottom sash and sill, possibly intended to stop a leak. Debris has gathered on interior surfaces.

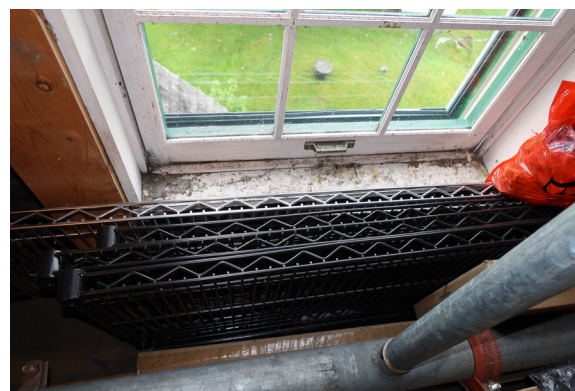
Fair condition. Glazing is intact. Glazing putty and paint are not cleanly applied and are visible from the interior. Paint is in poor condition on the exterior, estimated 20% missing or cracked. Wood elements are painted on the interior. Approximately 15% of paint on the interior sill is missing. Water

Figure 1-197. Debris and water damage at sill of Window 34. (EAV, 08/24/2021)

staining was observed at the interior sill. Debris has gathered on interior surfaces.

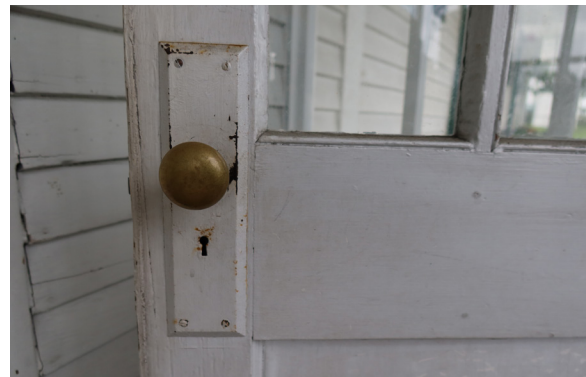
Fair condition. Paint is worn and missing where the door meets the casing. Paint on the exterior hardware is worn and missing. Paint on the exterior face of the door is darkened from dirt, scratched, and selectively repainted in areas.

On the interior, paint is worn and scratched. Paint is selectively repainted in a brighter white. Approximately 95% of paint on the door knob back plate is missing. Some rust and missing paint was observed at the hinges.

Figure 1-206. Missing and worn paint on and near hardware of Door 103B, exterior. (EAV, 08/24/2021)

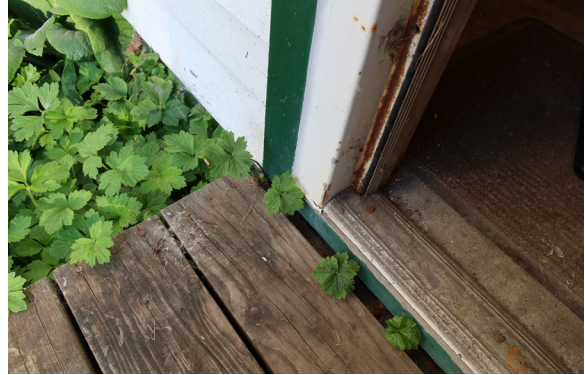
Fair condition. Paint is scratched and worn on both sides. Rust was observed on the exterior near the door knob and hinges and on the frame. Operation is smooth.

Figure 1-207. Rust at frame of Door 110. (EAV, 08/24/2021)

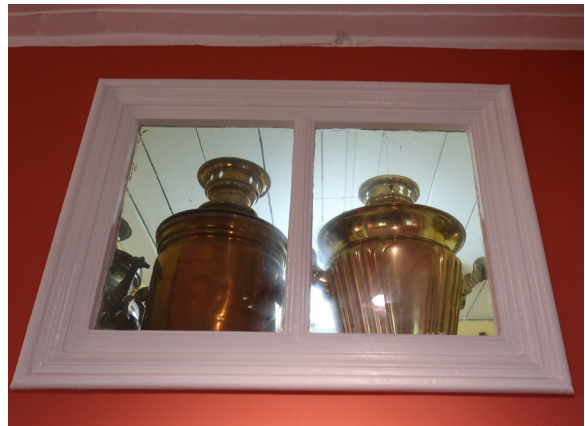
The glazing in the east lite is cracked, but remains within the sash. Paint is intact.

Figure 1-208. Fixed interior window, Entry 100 side. (EAV, 08/24/2021)

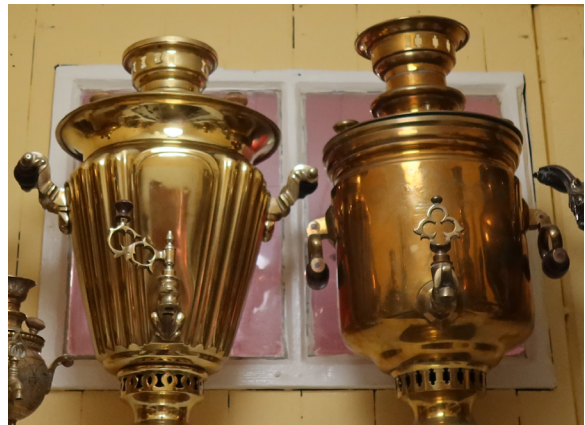
Figure 1-209. Fixed interior window, Pantry 106 side. (EAV, 08/24/2021)

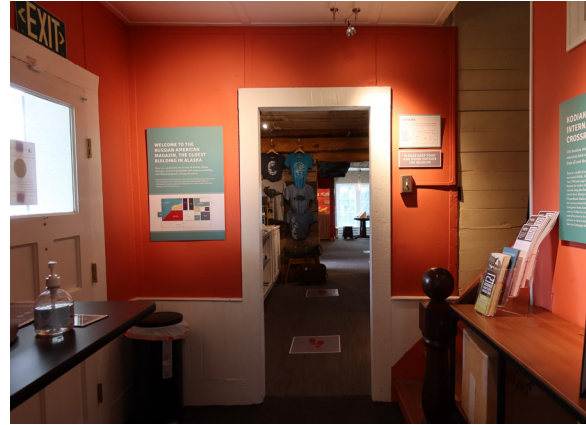
Originally a door was mounted in this frame but has now been removed and hardware locations on the frame are patched. Images from the 2019 exhibit construction process reveal that a historically incompatible modern four-hinge door was mounted here

Figure 1-210. CO 101 centered on the west wall of Entry 100. (EAV, 08/24/2021)

and removed in 2019. The 1985 floor plans showing the Erskine Era layout of the Magazin indicate that this existed as a doorway during the proposed expanded period of significance.

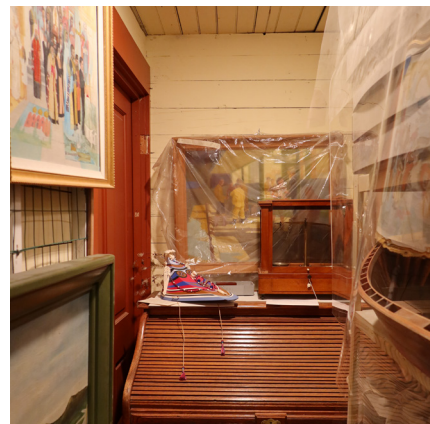
Figure 1-233. Door 203B is blocked by collections in Collections III 203. (EAV, 08/24/2021)

Fair condition. Historic hardware locations on the frame are unpainted.

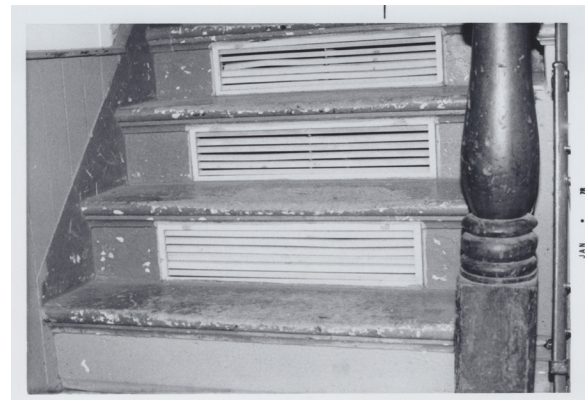
Three steps near the bottom are missing the ogee trim. These risers were replaced when ventilation grilles were removed from the risers.

Figure 1-283. Ventilation grilles in risers of three steps, since removed. (Kodiak History Museum, photograph developed January, 1978).

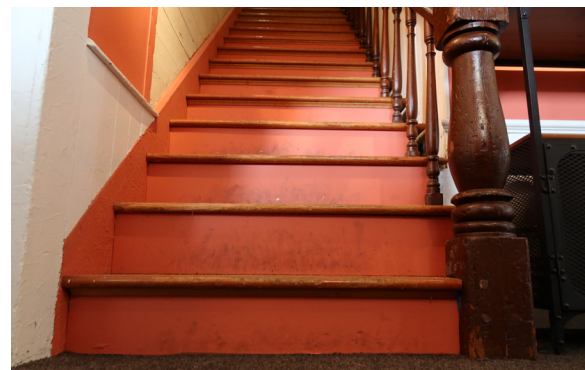
Figure 1-284. Facing north at the bottom of the stairs to the second floor. Note missing trim at replaced risers. (EAV, 08/24/2021)

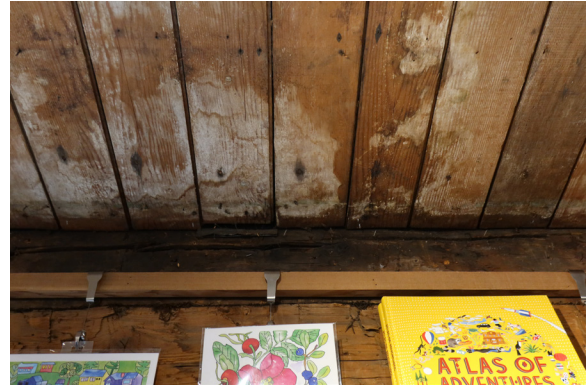
Good condition. Where not covered by casework, historic walls are in good condition. Portions of the south and east walls were not visible and thus could not be assessed. Some staining was observed at the ceiling above Window 04. Floors are in good condition.

Figure 1-288. Stained ceiling boards in Gift Shop 101. (EAV, 08/24/2021)

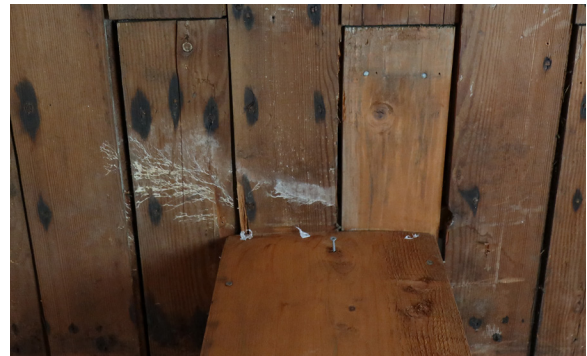
Good to fair condition. Floor finish is in good condition, however, the floor slopes strongly to the southwest. See Structural Section for additional information on floor slope. Ceiling finishes are in good to fair condition. Mycelium growth was observed on ceiling boards adjacent to the plumbing chase, indicating a leak. Water staining was observed on the alcove ceiling, indicative of a roof leak.

Figure 1-286. Growth on ceiling boards near the plumbing chase in Museum I 102. (EAV, 08/24/2021)

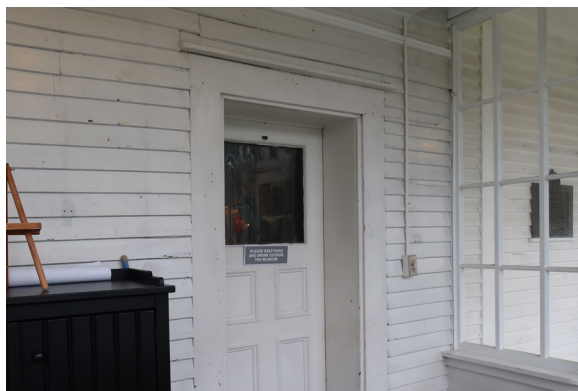
Good condition. The floor and ceiling are in good condition. The north wall is in good to fair condition. Paint is mostly intact, with some scratches. Other walls appear to be in good condition. The west and north walls could not be assessed where obstructed by the built-in benches.

Figure 1-291. Scratched paint at north wall of Sun Porch 103. (EAV, 08/24/2021)

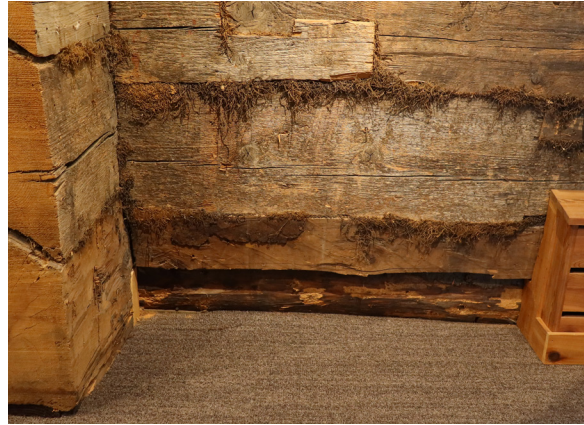
The north wall is in good to fair condition. The bottom log is not original. The face of this log sits shy of the interior face of the wall and is not hewn flat like the other logs. Evidence of past insect infestation was observed. Gaps in the wall around this log are filled with wood plugs and cotton rags.

Figure 1-289. Previously replaced log at north wall of Museum II 104. (EAV, 08/24/2021)

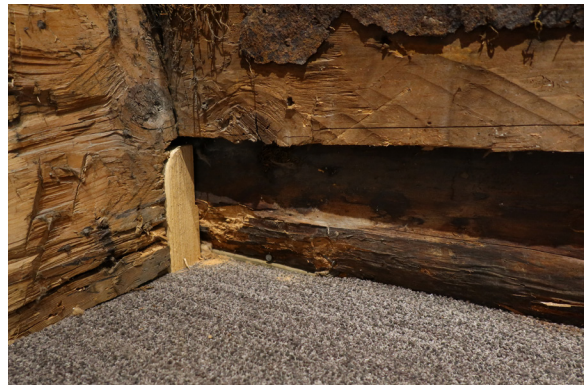
Figure 1-292. Previously replaced log at north wall of Museum II 104. (EAV, 08/24/2021)

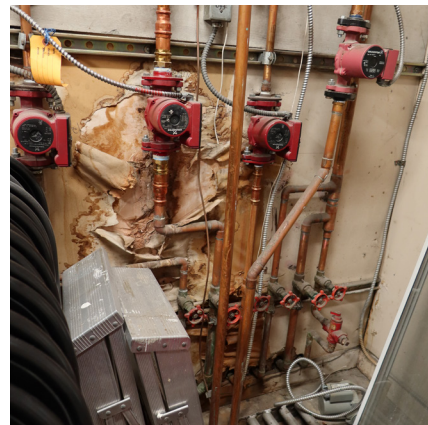
The mechanical room is in fair to poor condition. Gypsum board at the north wall is in fair condition. Some staining, gouges and water damage is observed.

Gypsum board on the west wall is in poor condition. Water damage from past pipe leaks has significantly degraded the material. Holes remain in the wall from pipes and conduit that have since been removed.

Figure 1-294. Damaged gypsum wall board in Mechanical Room 110. (EAV, 08/24/2021)

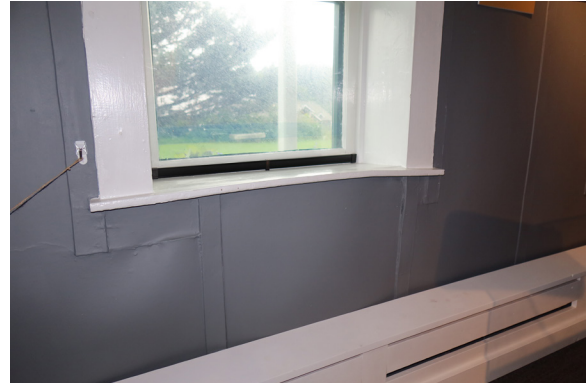
At the south side of the room, gypsum wallboard and battens below Window 01 is warped. The window sill is cracked, indicating movement within the wall. Paint is intact

and surfaces are dry. Observed warping is assumed to be from past settlement and/or water damage that is not currently active.

Figure 1-296. Warped sill and finishes at Window 01 in Museum IV 112. (EAV, 08/24/2021)

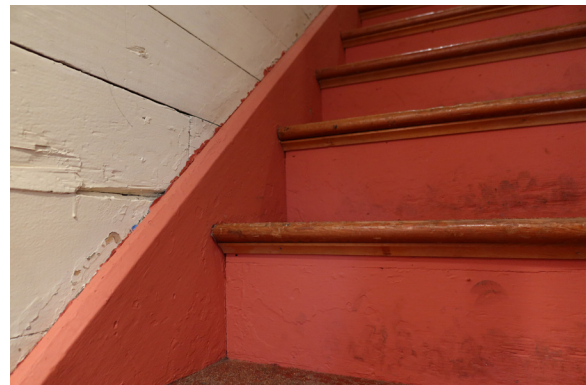
Good to fair condition. Paint on risers is scuffed and marked from wear. Wood elements are slightly worn but mostly intact.

Figure 1-297. Scuffed risers and thick paint at the stairs. (EAV, 08/24/2021)

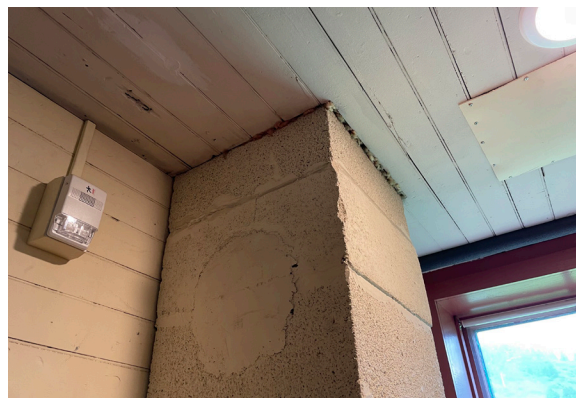
Good to fair condition. Walls and ceilings are patched in some areas. Paint is intact. Floors are in fair condition. The carpet has some staining and is worn from use. The wall base is in good condition and paint is intact.

Figure 1-328. Patched ceiling and abandoned chimney in Stair Hall 200. (KAC, 08/24/2021)

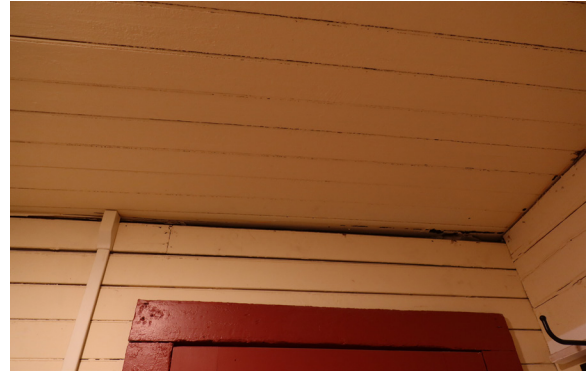
Figure 1-335. Gap at the top of the south wall of Staff Restroom 207. (EAV, 08/24/2021)

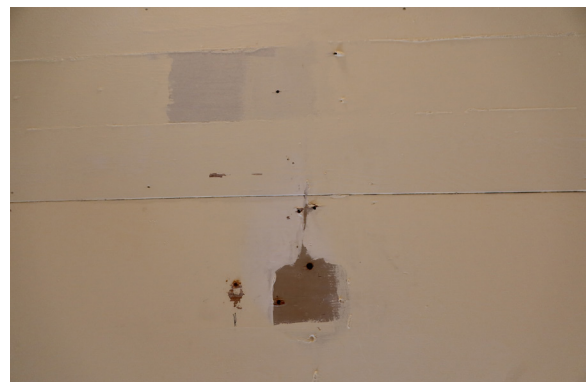
Figure 1-334. Missing paint at ceiling of Office II 206. (EAV, 08/24/2021)

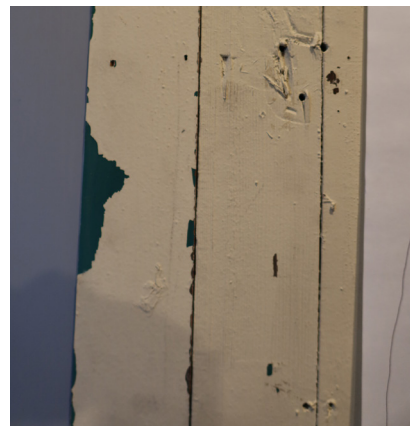
Figure 1-336. Thickly applied and missing paint at wall boards in Director's Office 208. (EAV, 08/24/2021)

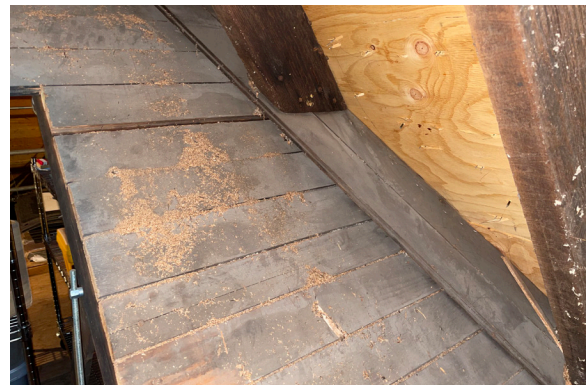
This is an unfinished and unoccupied space below the south gable dormer. It was previously inaccessible from the interior, divided from the rest of the attic by tongue and groove roof sheathing. An access hole is cut into the sheathing. Smoke staining on the face of the sheathing is not present at cut edges, indicating that the cut was made post-fire.

Figure 1-342. Sheathing with cut access hole, Attic II 301 side. (KAC, 08/24/2021)

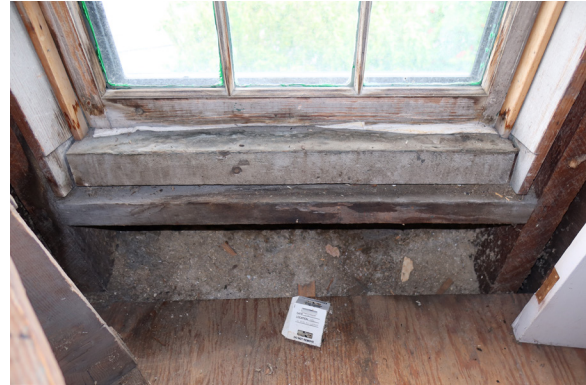
Wood framing members on the west wall are water-stained near the sill of Window 33.

Figure 1-344. Water-stained wood around the sill of Window 33. (EAV, 08/24/2021)

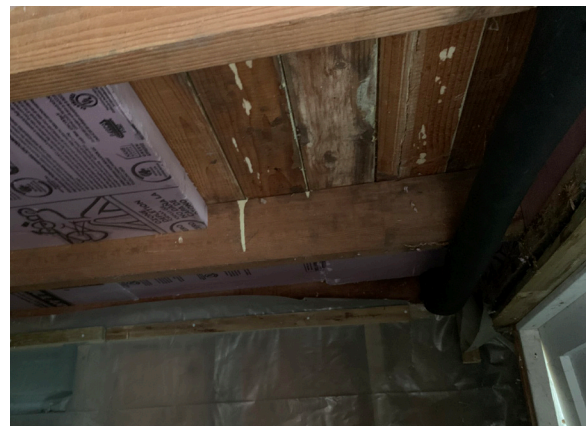
Figure 1-347. Interior face of the south wood stud foundation wall of the Sun Porch as seen through the plastic sheeting (CBB, 08/24/2021)

The portions of the wood stud foundation walls of the Sun Porch that could be observed are in fair condition (the interior faces of the foundation walls are lined with plastic sheeting so could not fully be observed). Because the soil has not encroached on the foundation walls of the Sun Porch as it has at the Alcove, the wood elements are likely in better condition, especially near the tops of the foundation walls. However, given the high moisture levels of the rest of the crawlspace areas and the proximity of the wood elements to soil, the bases of the wood stud walls are likely deteriorating.

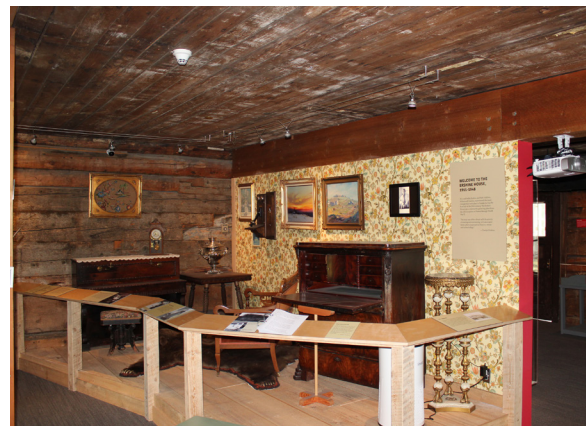
Figure 1-350. Dropped beam supporting the second floor visible at the dividing wall in Museum I (102) (CBB, 08/25/2021)

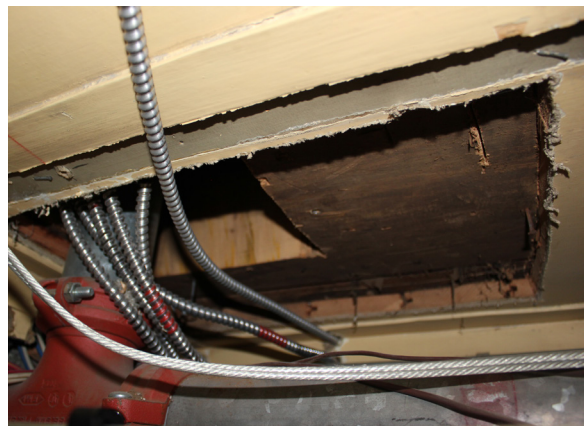
Figure 1-352. Second floor beam of the Magazin on the east half of the structure. Note the large hole cut in the beam to allow the piping to pass up to the second floor (CBB, 08/26/2021)

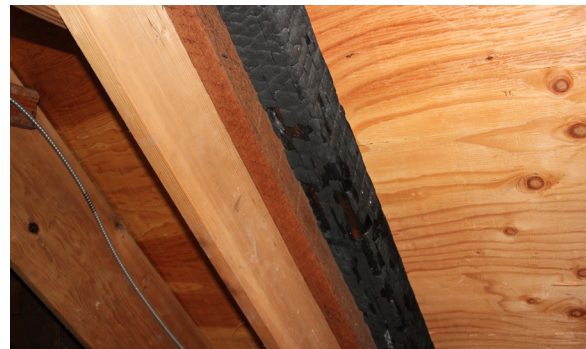
Figure 1-363. Charred 4x4 rafter with sisters (CBB, 08/26/2021)

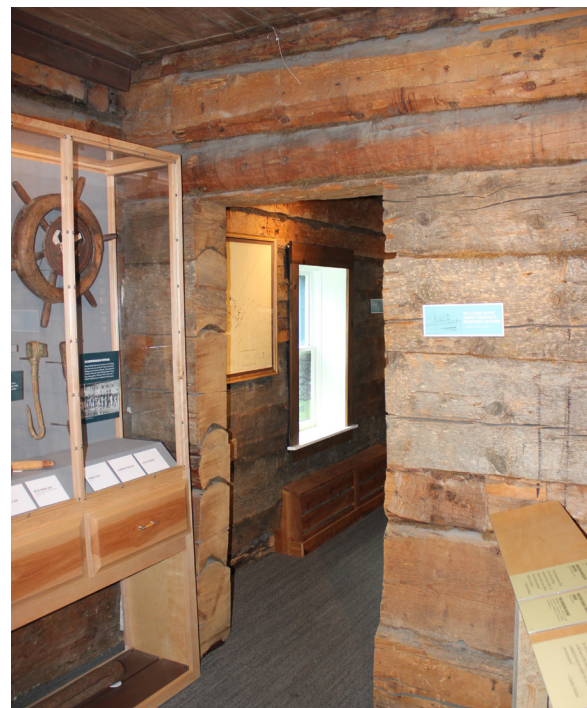
Two door openings were cut into the interior log wall after the original date of construction and there are no dedicated structural elements or connections to keep the portion of the wall between the openings in place (Figure 1-369). Similarly, an opening was

Figure 1-369. Opening created in the interior log wall after the original construction (CBB, 08/25/2021)

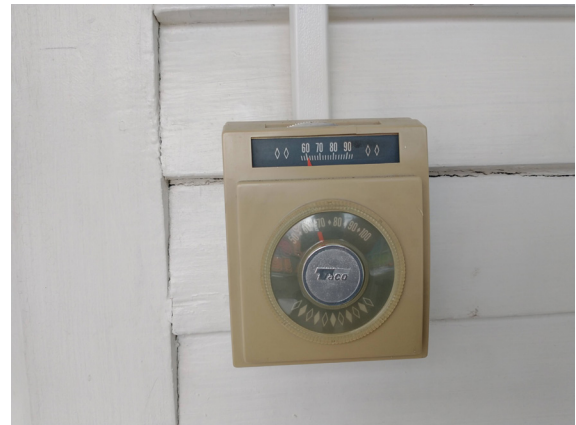
The boiler system has (5) temperature of control zones, each of which has a dedicated pump that operates on a call for heating. It was noted that the zone serving the East side of the first level has no thermostat located in the space. There is no building-level controls system. Figure 1-375

Figure 1-375. Hydronic Thermostat (JSW 8/24/2021)

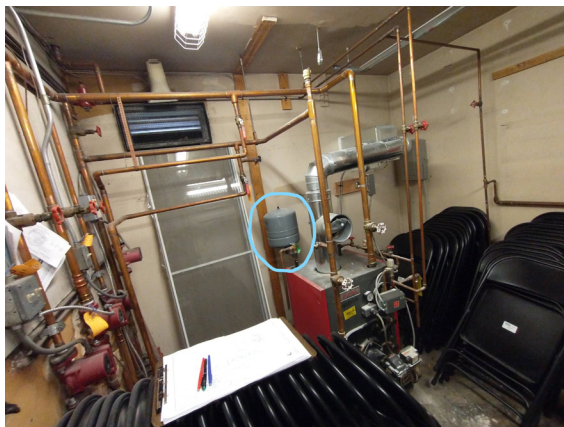
The boiler expansion tank is supported by pipe fittings only and is not supported via any structure. Figure 1-373

Figure 1-373. Poorly Supported Expansion Tank (JSW 8/24/2021)

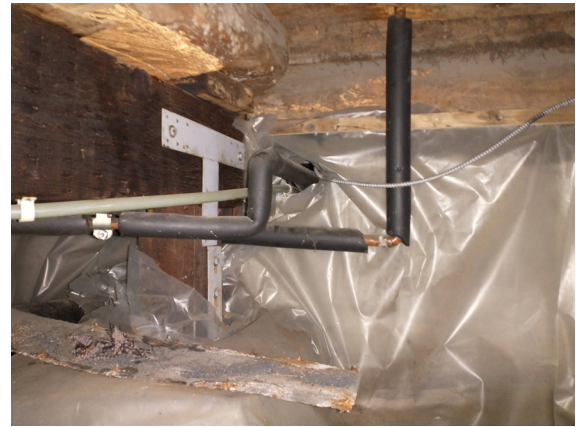
The hydronic piping throughout the building is copper excepting a few areas in the crawlspace where the piping was noted to have been replaced with PEX. The piping is poorly supported in many places throughout the building. The copper piping's exact age is unknown but is assumed to have been installed as part of the 1980 Heating Replacement scope. Figure 1-376

Figure 1-376. Hydronic Piping In The Crawlspace (JSW 8/24/2021)

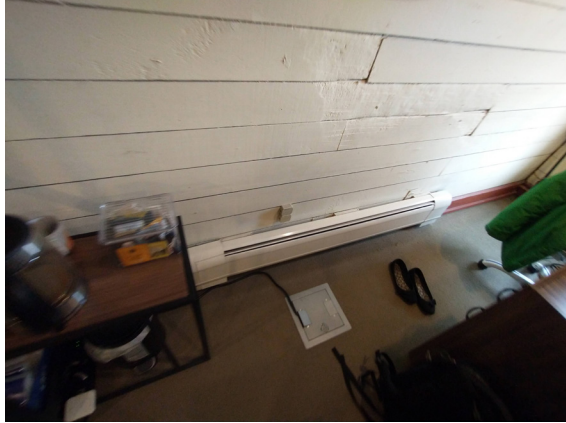
extremities of the building. Piping was noted to be insulated with elastomeric insulation which is noticeably hard to the touch and corroded automatic air valves were noted on the second level. Piping is uninsulated in the mechanical room. Baseboard radiators on the second level do not have decorative covers. Figure 1-377

Figure 1-377. Second Level Baseboard Radiator (JSW 8/24/2021)

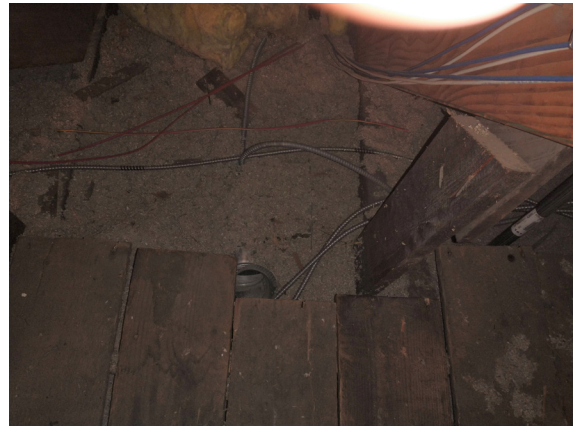
There is one ceiling mounted exhaust fan in each of the two restrooms. The main level exhaust fan discharges to the building exterior and the 2nd level exhaust fan discharges into the attic space. Figure 1-380

Figure 1-381. Second Level Restroom Exhaust Into Attic (JSW 8/24/2021)

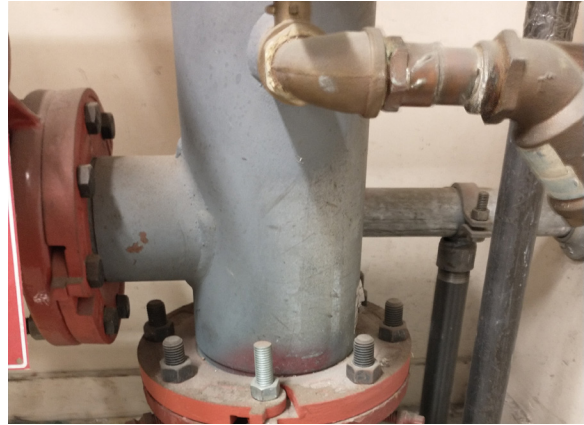
Figure 1-383. Combination Fire and Water Entry (JSW 8/24/2021)

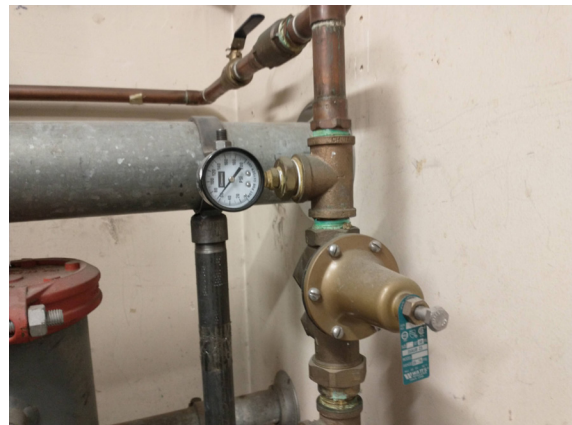
Figure 1-384. Domestic Water PRV (JSW 8/24/2021)

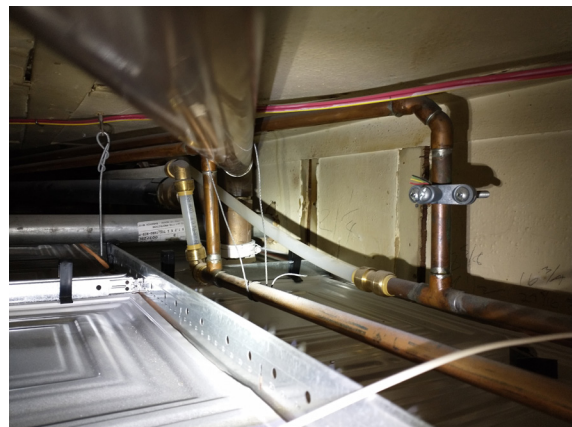
The water lines throughout the building are a mix of copper and PEX piping. PEX piping serves the more recently installed fixtures (break room sink, first level restroom) while copper piping serves the older fixtures (main distribution, second level restroom). The hot and cold water piping is ½" diameter throughout the building. The majority of the domestic water piping is uninsulated. Figure 1-385

Figure 1-385. Copper to PEX Domestic Water Transition (JSW 8/24/2021)

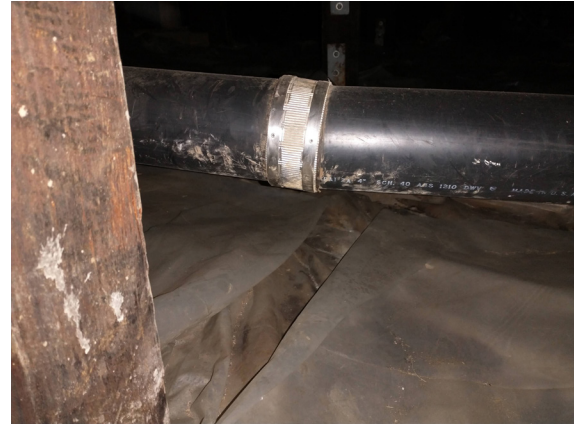
Waste piping in the crawlspace is ABS and appears to be in fair condition. The waste piping in the crawlspace is poorly supported and fittings were noted to be poorly joined in some locations. Figure 1-386

Figure 1-386. ABS Piping in Crawlspace (JSW 8/24/2021)

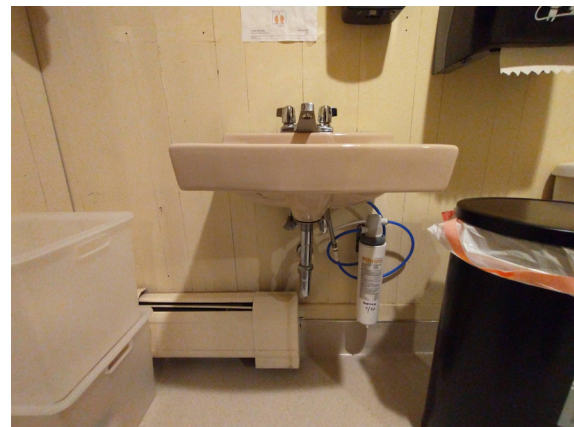
Water filters are installed under the break room sink and the second level restroom lavatory. Figure 1-388

Figure 1-388. Second Level Lavatory Filter (JSW 8/24/2021)

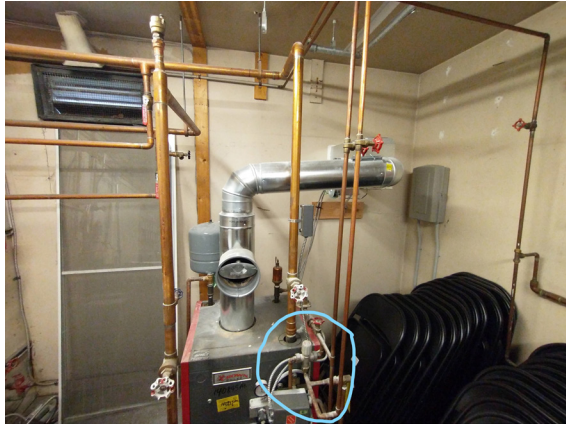
Domestic hot water is generated via a side-arm off of the hydronic boiler system. There is no domestic hot water recirculation in the building. Figure 1-389

Figure 1-389. Domestic Hot Water Mixing Valve (JSW 8/24/2021)

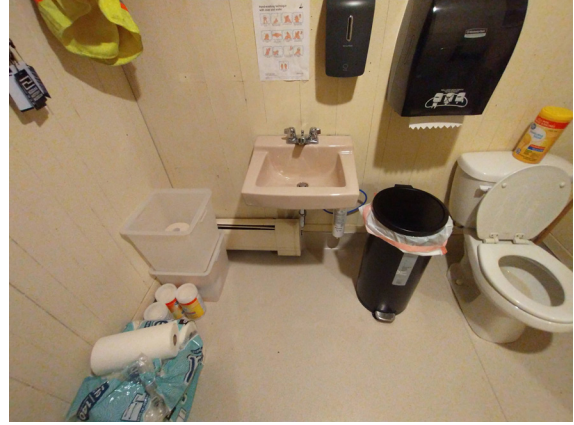
Figure 1-392. Second Level Restroom Fixtures (JSW 8/24/2021)

Needs a majority of the plumbing replaced. None of the current fixtures are ADA-complaint. Refer to the Architectural - Accessibility section for additional accessibility-related information.

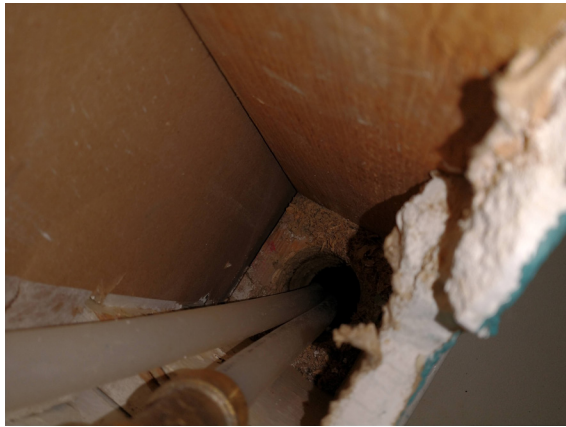
with a breakroom sink and one exterior mounted hose bibb. Domestic supply piping is routed within the crawlspace to serve the break room sink. There is a floor drain in the mechanical room the piping for which could not be located in the crawlspace. The exact routing of this piping is unknown. Figure 1-390

Figure 1-390. PEX Piping Down in Restroom Wall to Crawlspace (JSW 8/24/2021)

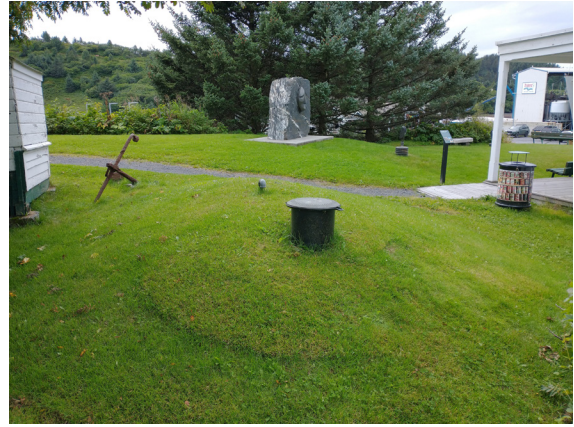
The building is supplied with #2 fuel oil (diesel) via a 500-gallon tank buried outside of the building that was installed in 1989. The diesel tank only serves the boiler in the mechanical room as there are no other fuel-fired pieces of equipment. Based on the 2004 RSA report, this tank is not believed to be a double-walled vessel. Figure 1-393

Figure 1-393. Fuel Tank Location (JSW 8/24/2021)

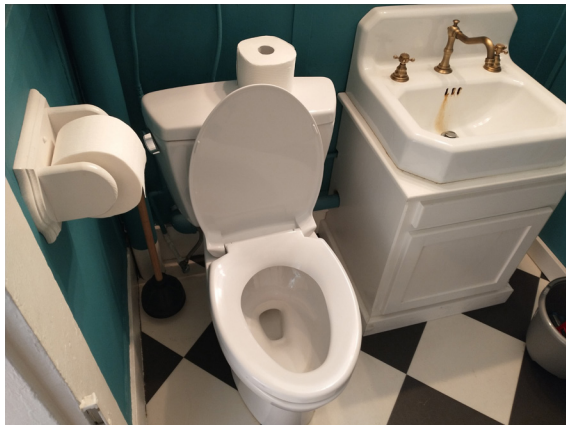
Figure 1-391. First Level Restroom Fixtures (JSW 8/24/2021)

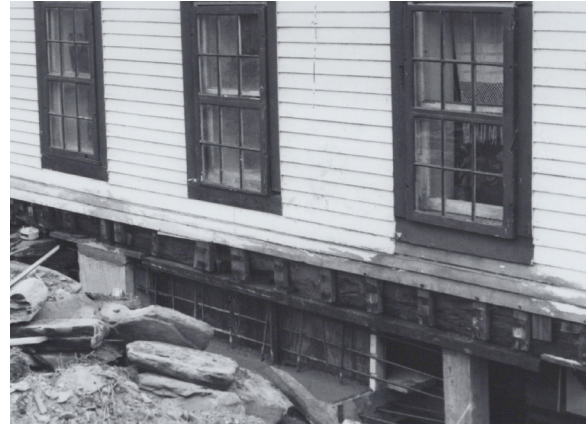
Where storm windows are missing (Windows 28 and 34), some weathering of paint and

Figure 5-1. Historic twelve-lite storm windows along north facade. (Kodiak History Museum, ca. 1970s)

glazing putty has begun to occur and will continue without a storm. Gently sand and repaint wood elements at these two windows. Replace any loose or cracked glazing putty. Construct historically compatible wood-frame storms with twelve lites, arranged in a six-over-six pattern for these two windows.
